DEPARTMENT OF TRANSPORTATION

Quality Assurance and Source Inspection

WELDING INSPECTION REPORT

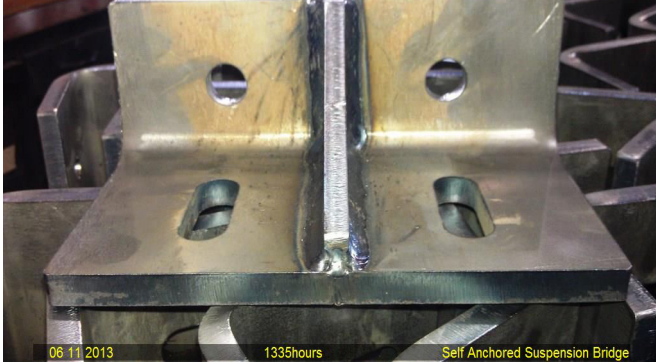
This QA performed random initial verification on the 1/4" fillet weld that was just completed on 142 pieces of rear tie-in brackets. The surface profile of the fillet welds on the brackets was noted and the size of the fillet weld was also measured. Generally, all the brackets that were verified deemed to conform to the requirements of the project per AWS D1.1 code. This initial verification was made while waiting for USA Hoist Quality Control (QC) Inspector Robert Zimny to perform his inspection.

At USA Hoist fabrication shop, 142 pieces of rear tie-in brackets for tower elevator were completely welded with 1/4" fillet weld on all sides of the stiffener plate to the bent plate.

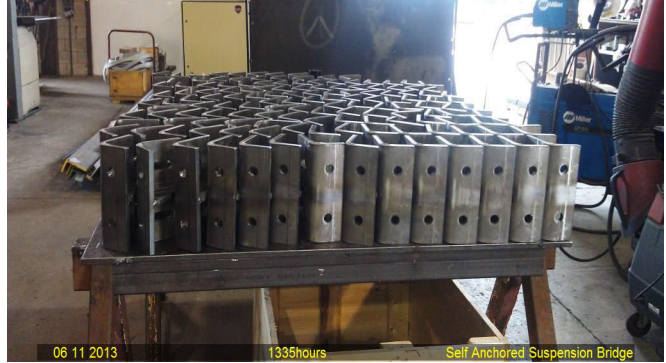
At USA Hoist fabrication shop, 142 pieces of rear tie-in brackets for tower elevator were completely welded with 1/4" fillet weld on all sides of the stiffener plate to the bent plate.
